# CITATION

for Historical Restoration

**The Sherry-Netherland**

**Orsman Design, Inc.**

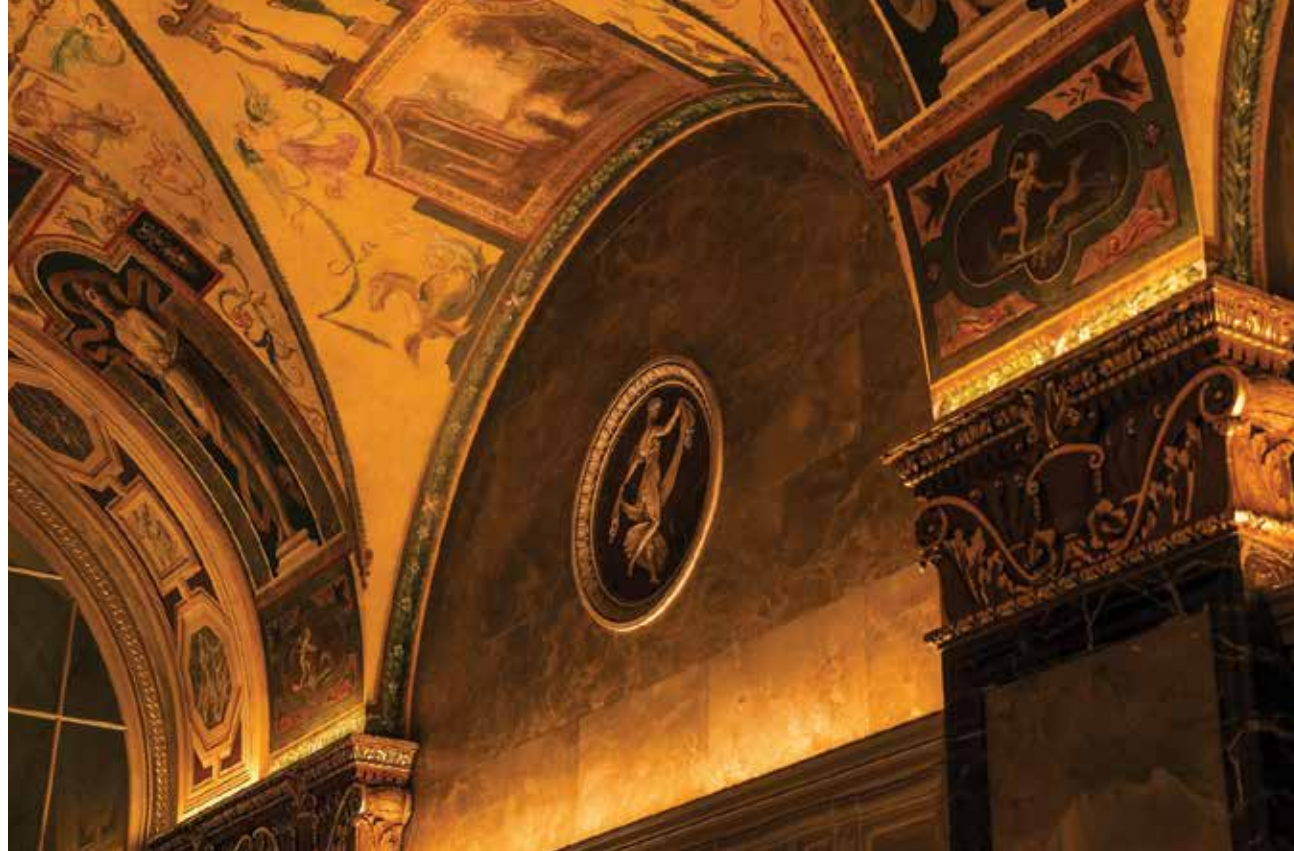
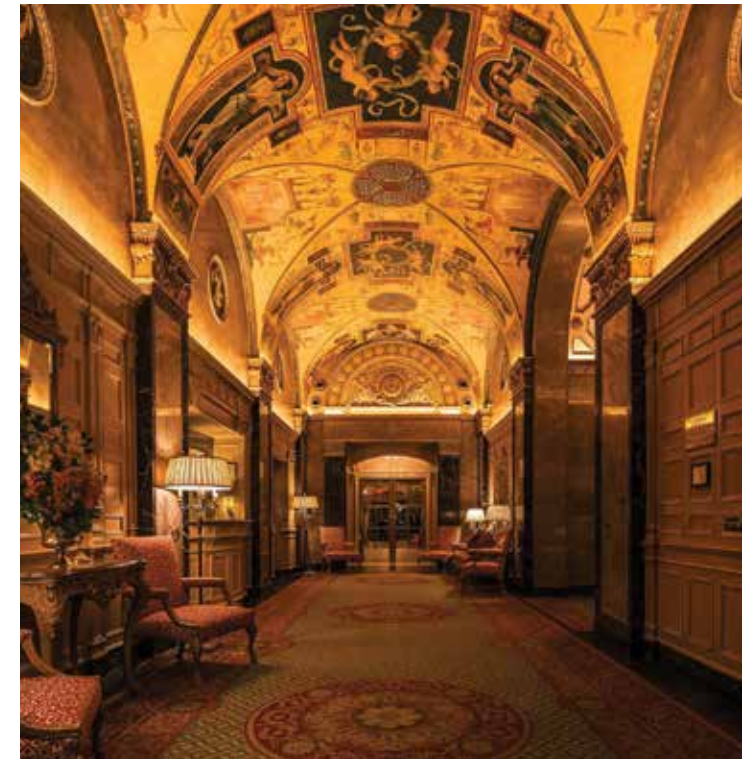
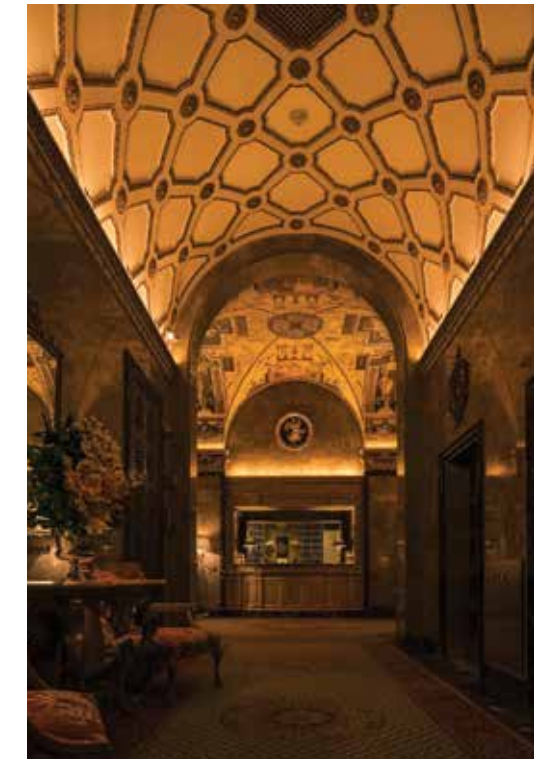
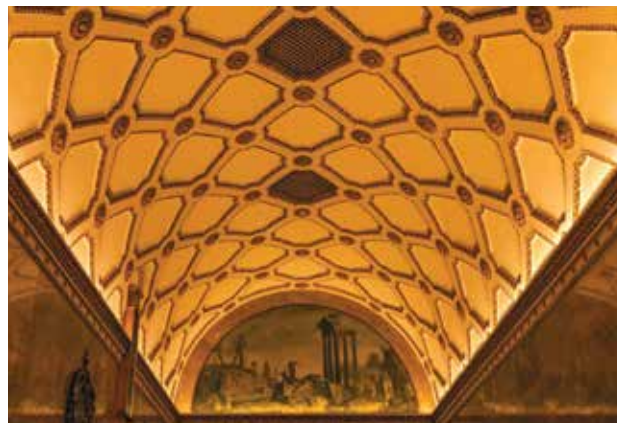
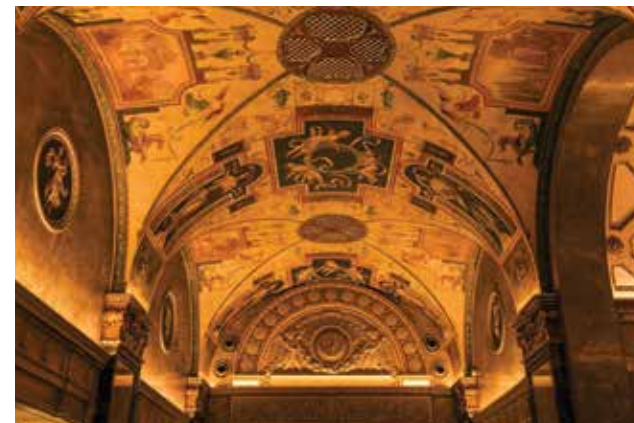
More than a dozen coats of paint and plaster had covered the 860 sq ft mural, and it took five conservationists 6 months to restore. Once completed, Orsman Design managed the lighting installation. As there was no preexisting wiring, extreme care was taken to conceal all the wiring and remotely locate linear LED drivers.

The intent was to illuminate the ceiling but not draw attention to the light sources. This process involved extensive mock-ups, testing and experimentation with multiple LED products. The product selected is the one that best fits the hotel's history; more on the warmer side at 2300K. As they dim, the LEDs emulate the color shift found in incandescents, growing even warmer as they dim down to 1 percent.
